# FATIGUE AND STATIC PROPERTIES OF WELDED JOINTS IN LOW ALLOY STRUCTURAL STEELS

A Report of an Investigation Conducted by

THE OHIO RIVER DIVISION LABORATORIES

14 JANUARY 1955

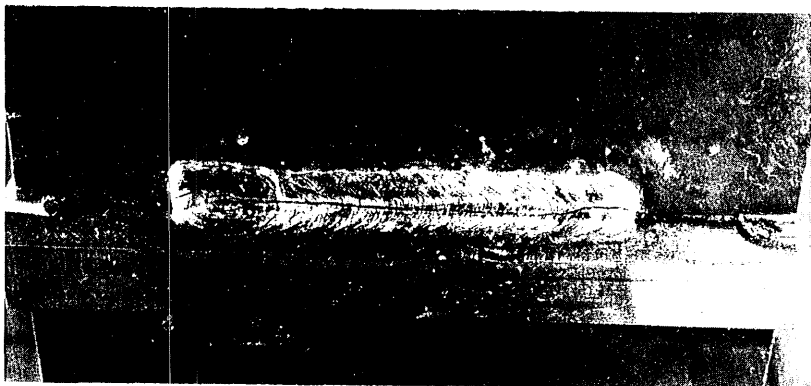
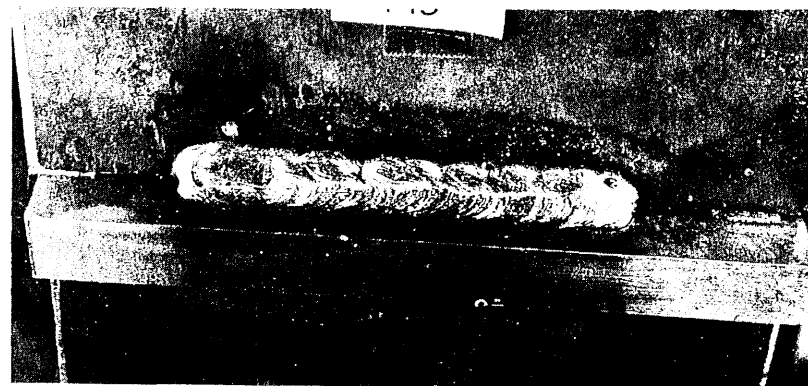
a. FATIGUE CRACKS

b. FRACTURE SURFACES

FIG.12 FATIGUE FAILURES OF TEE FILLET-WELDED JOINTS

The fatigue cracks of the tee fillet specimens occurred in the weld metal on a line approximately through, or slightly on the tee-plate side of, the throat of the weld. From an examination of the fatigue cracks, after failure, and an examination of the fracture surfaces, after the specimens were pulled apart statically, it appeared that most of the fatigue failures had initiated away from the ends of the weld. However, it is difficult to determine the point of origin of

the failure in a fillet weld as the fatigue failures generally spread along most of the length of the weld with little indication as to the sequence of failure. As shown in photographs of typical fatigue cracks and fracture surfaces, Fig. 12, the fracture surface consisted of two distinct regions; a fairly smooth, planear, surface having an angle less than 45 degrees from the tee plate and a rough fibrous appearing surface having an angle greater than 45 degrees from the tee plate. The fibrous appearance of the latter surface gives the impression that it was entirely static fracture. However, the smoother portion, a region of fatigue fracture, in no case extended to the surface of the weld as did the fatigue cracks, so the rougher portion must contain the final stages of the fatigue failure as well as the static fracture. From this similarity of the static region with part of the fatigue region, it would seem that the rate of propagation of the fatigue fracture increases when the plane of failure changes. However, another reason for the smoother appearance of the area which failed in the earlier stages is that the surfaces had been pounded together more times than those portions of the fatigue crack which developed later. Apparently, the change in the angle of the surface relative to the tee plate is due to the alteration of the stress pattern in the weld as the fatigue crack spreads.
